Onepoto Lagoon Required Maintenance February 25 2013

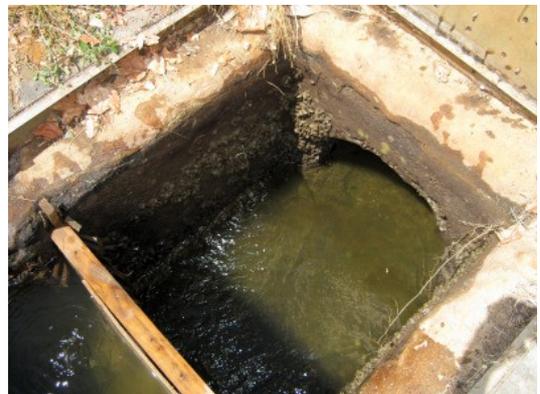
A plywood panel with rubber sheet was placed over the weir gate boards and down over the sill on the pond side. This was held in place over the sill by a bag of sand. It cut down the leakage significantly. It was noticed at the time that there was a crack in the side of the weir gate chamber next to the outlet pipe that was also leaking water bypassing the weir gates.

On **February 25** at low tide the weir gate chamber was inspected again. The sill was not leaking much but the crack in the concrete was gushing water and emptying the pond which was now even lower than the previous day.

The weir gate chamber, the leak is alongside the exit pipe top centre in the photo.

An attempt was made to plug this and it seems to be successful so far.

- * **Weir Gate chamber cracked concrete.**
- * **Weir Gate sill.**
- * **Flap Valves.**
- * **Fountains.**
