State of the Onepoto Lagoon

February 3 2013

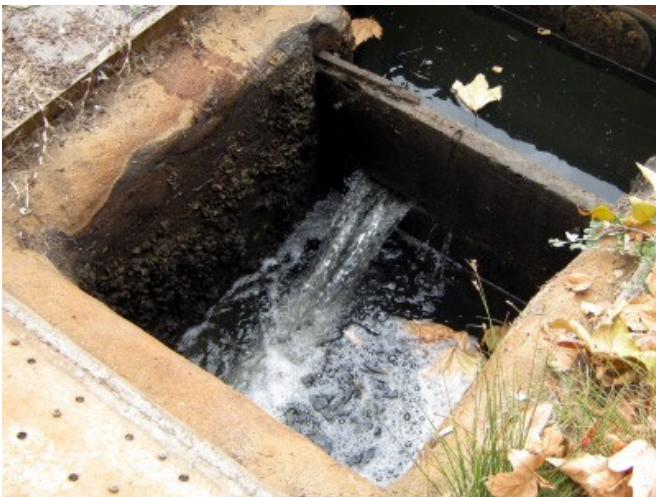
The timber weir gate boards had rotted out and there was a large leak between the two boards.

These boards had been installed in 2007 after the previous set had become rotten.

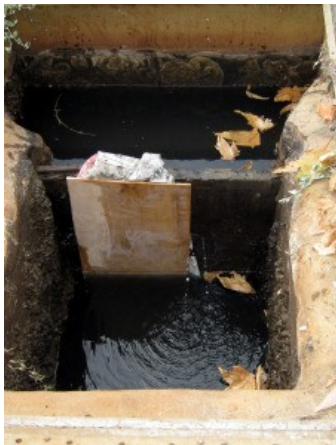
The top trim strip had mostly disappeared and the timbers were soft to the touch. At this stage,

being late Friday afternoon, we needed to make a temporary repair by patching the boards.

Ian went for some plywood while I found a sack that could block the water in the meantime. With plywood both sides the leak was down to a dribble.

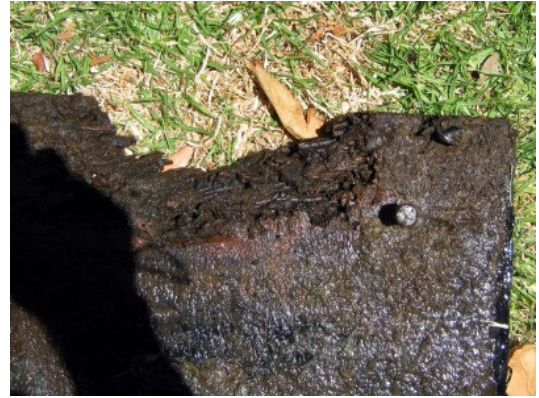
When we went to remove the old boards they disintegrated being infested with gribble worm as well as being rotten.

The sill is also rotten but this seems to be concreted in and can't be easily replaced.

The next day, Saturday, I obtained some retaining wall timber cut to size. The ends needed notching to bring the thickness down to 48mm, and the faces were planed to be flat and straight.

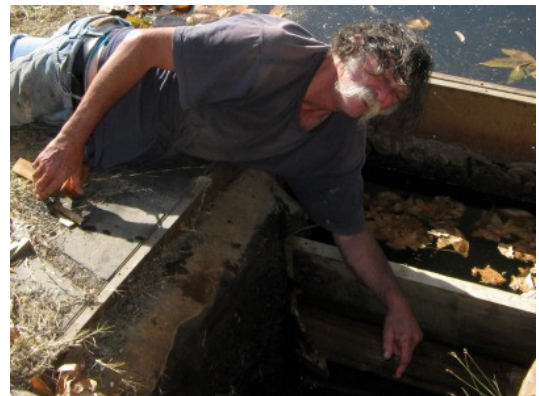
The new boards fitted into place with the water levels almost equal each side and were wedged to hold them from floating. We then needed to return later when the tide had dropped to check for leaking.

Wedges were needed to plug leaks around the sides where the concrete is rough and eroded. The board edges sealed nicely, but the sill was soft and failing and some leaking was noticed.

The sill must be replaced. This may require a coffer dam both sides of the weir gates while the old sill is dug out and replaced, preferably with something that will last better.
