## Report on Carbon Boat damage

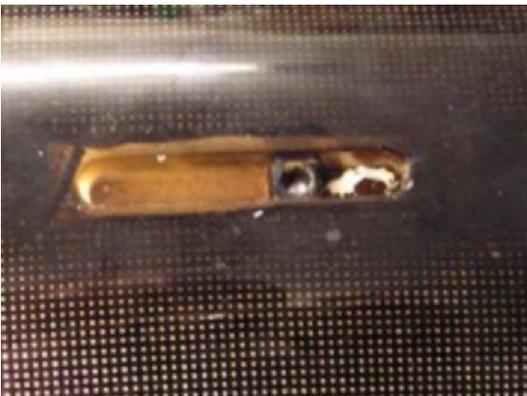
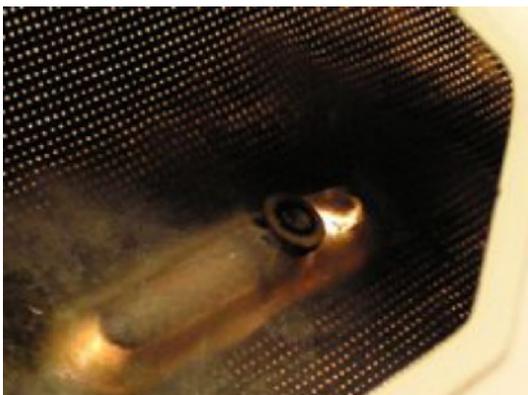
During a race Bruce's new Carbon Fibre 33 started to sink. He recovered it and it was found the the keel was raked forward approx 5 degrees. Bruce reported:

1. The boat was dropped onto a grass surface from the stand and landed on the keel bulb. The keel pivoted forward and the top of the keel punched through the keel box. The stainless steel shaft was bent.

2. The keel box had been reinforced with two layers of fiberglass matt, but this was not enough to stop the penetration.

3. In assembling the boat the fit of the keel to the keel box is very poor. The keel box is distorted and a lot of work is required to shape the keel top to fit.

I believe the keel box area is unnecessarily weak. A better solution would be to mould in the original ABS keel insert.

You may still need to fill the open void by epoxy putty or something like that, so that the proper matching can be obtained. This may be necessary, even if the damaged Carbon Hull is fixed by laminating the interior. I've personally done this by placing the wax on the hull socket, before applying the putty on the top of the keel. That way, the keel can be taken off from the hull with perfect surface fit, even after the epoxy putty is cured.
