Meeting at Onepoto 10 June 2009

The purpose of the meeting was to investigate the problems at the pond and to produce a plan to put before the Community Board to resolve these.

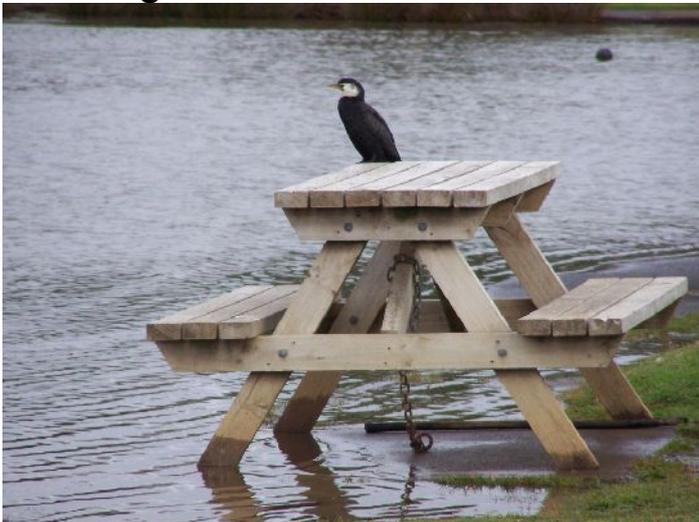
Desilting the Pond:

The recent rain had raised the pond over the paths and the runoff had made the water very brown and cloudy. This meant that it was not possible to see the silting or how blocked the culverts were. I had a copy of the OLCC Onepoto Manual and this had photographs that illustrated the problem areas and had a map showing the inadequate depths in the pond.

The plan for desilting the pond involves pumping the silt directly across the road and into a low-lying area which currently gets water logged during rain, as observed. The area will be prepared with drainage and dam walls to contain the silt and leave it to drain and solidify. It will eventually raise the ground level and, after covering with top soil and grass, will make that area more usable.

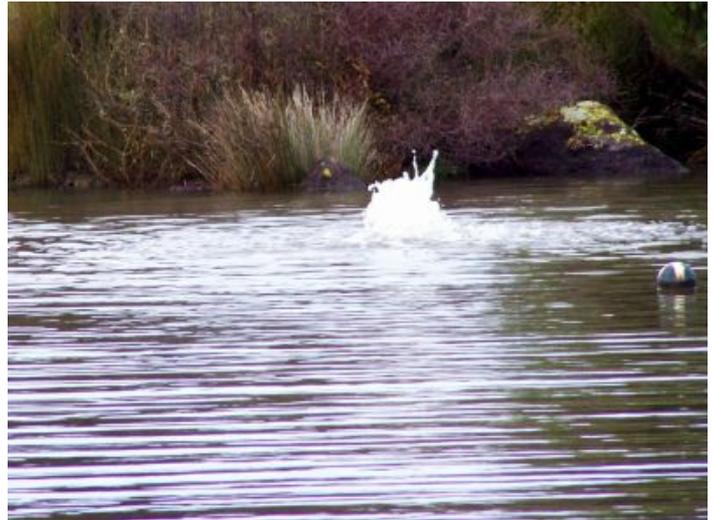
The Fountains:

The filters and fountain heads have been removed so that there is no restriction to the flow with the debris being pumped through with the water. The removal of the heads meant that there was no height to the flow.

The current intake is well out from the pond wall and in the deeper part of the pond. This makes it inaccessible but leaves it liable to ingesting silt and rubbish while also allowing mussels and weed to grow around and inside it.

It will be necessary to reconstruct the fountain pump intake with a large pre-filter that is directly accessible. This would give a much larger area of filter making it less liable to blockage while allowing it to be cleaned easily from the bank.

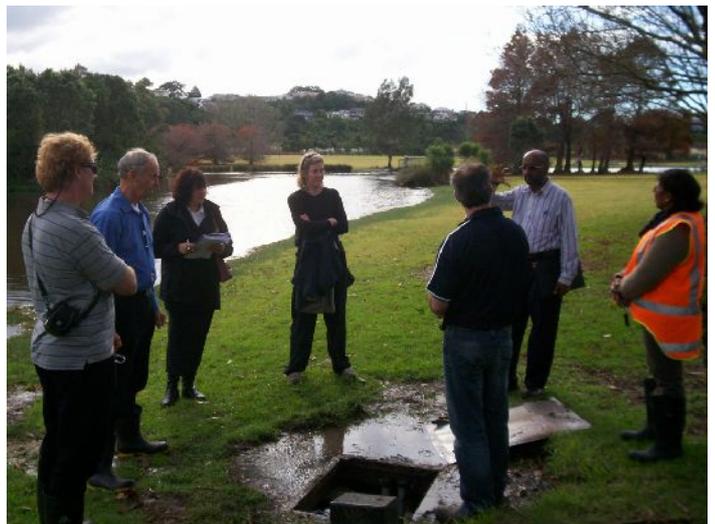
Around the underground pump housing.

The various parts of the pond and storm water streams were looked at: the flap valves need some new chain; the culverts need clearing; a new lock is needed on the weir gate cover.
