Onepoto Lagoon Coordination Committee

November 2007

4. The problems at the pond

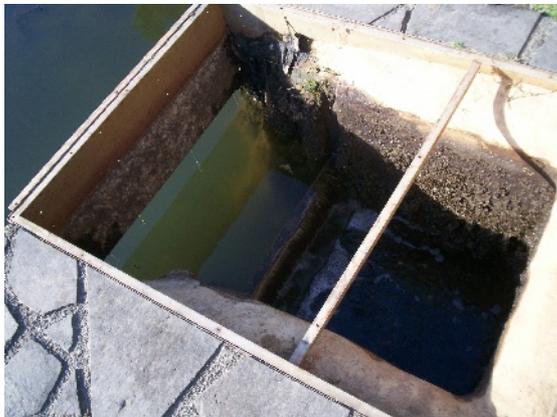
Removing one or more boards will allow the pond to drain at half tide or lower and will allow inflow above half tide if the flap valves are open.

There is no storage for the boards when they have been lifted and they cannot be left. They are taken away and this makes sharing the flushing responsibility difficult.

Update: The angle iron crossbar shown in the photograph has broken away from the frame and sits across the concrete shoulders of the sump. The boards can be left by resting them on the rear shoulder and this bar, possibly tying them in place.

The boards cannot be reached without wading when the pond overflows. A vertical rack system is desired which could be operated remotely with a wheel.

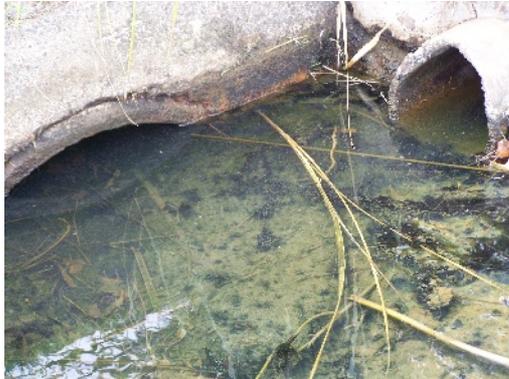
The north end of the pond has an inflow from the fields under the road. The pipe (left) is extremely silted almost to the point of completely blocked.

For several metres from the inflow the silting has reduced the depth to just a few inches where it should be over a metre.

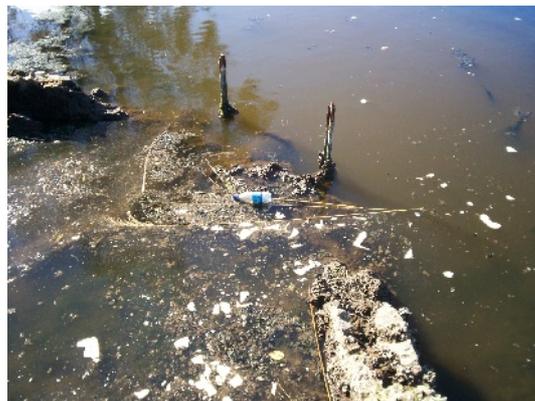
Between the two main ponds and under the bridge there is a dam arrangement which is partly demolished and supplemented by a pipe. This restricts the flow from the sailing pond and increases the number of tides needed to complete the flushing of the ponds.

The pipe appears to be blocked with silt which restricts the outflow considerably.

The vertical tracks indicate the position of a dam gateway, the surrounding concrete work has been reduced but still gives a level approximating the top of lower board in the control gate at the south end. The pipe is beneath this.

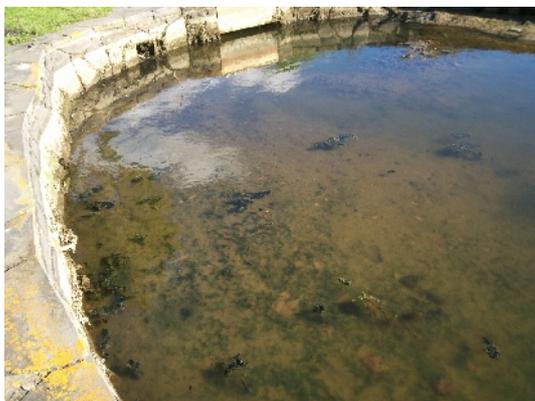
The south end next to the control gates is also very silted with a deeper pool around the control boards where it has been eroded by inflow. This highlights the amount of silt.

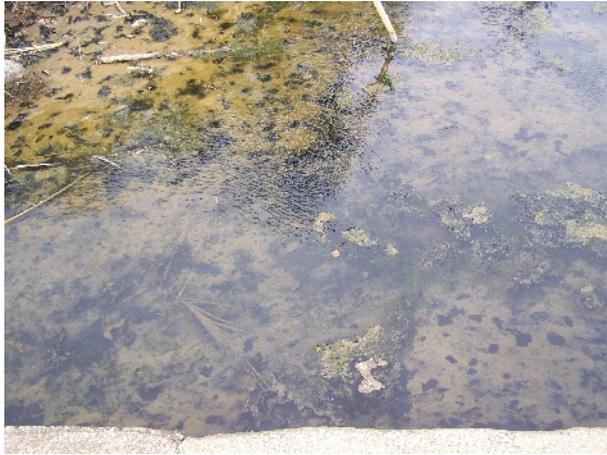
This is at the northern end close to the inflow by the clubrooms. It shows how shallow the silt has made this end but also the pollution. At times this has a very strong objectionable odour.

A pollution prevention officer went and checked out the northern end of the pond and ascertained that the smell (sulphurous) was due to the anoxic conditions of the pond, a particular problem in these types of situations in summer and due to a lack of flow through. There was no sewage contamination.

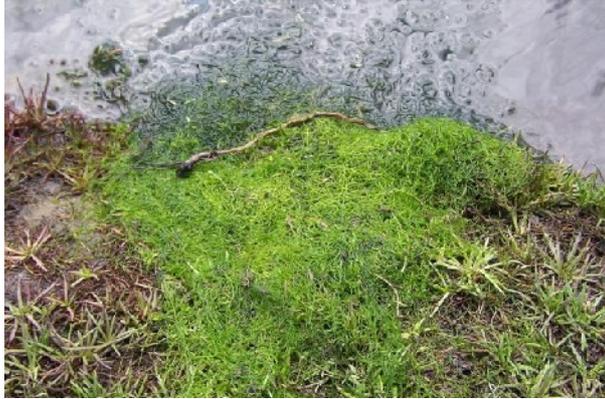
The weed, which is likely to be Pithophora or Ulothrix, often referred to as "horse hair" algee, grows extensively in the summer months and can choke the pond. Over two or three weeks in march 2007 growth accelerated and it covered the surface over

extensive areas of the sailing pond.

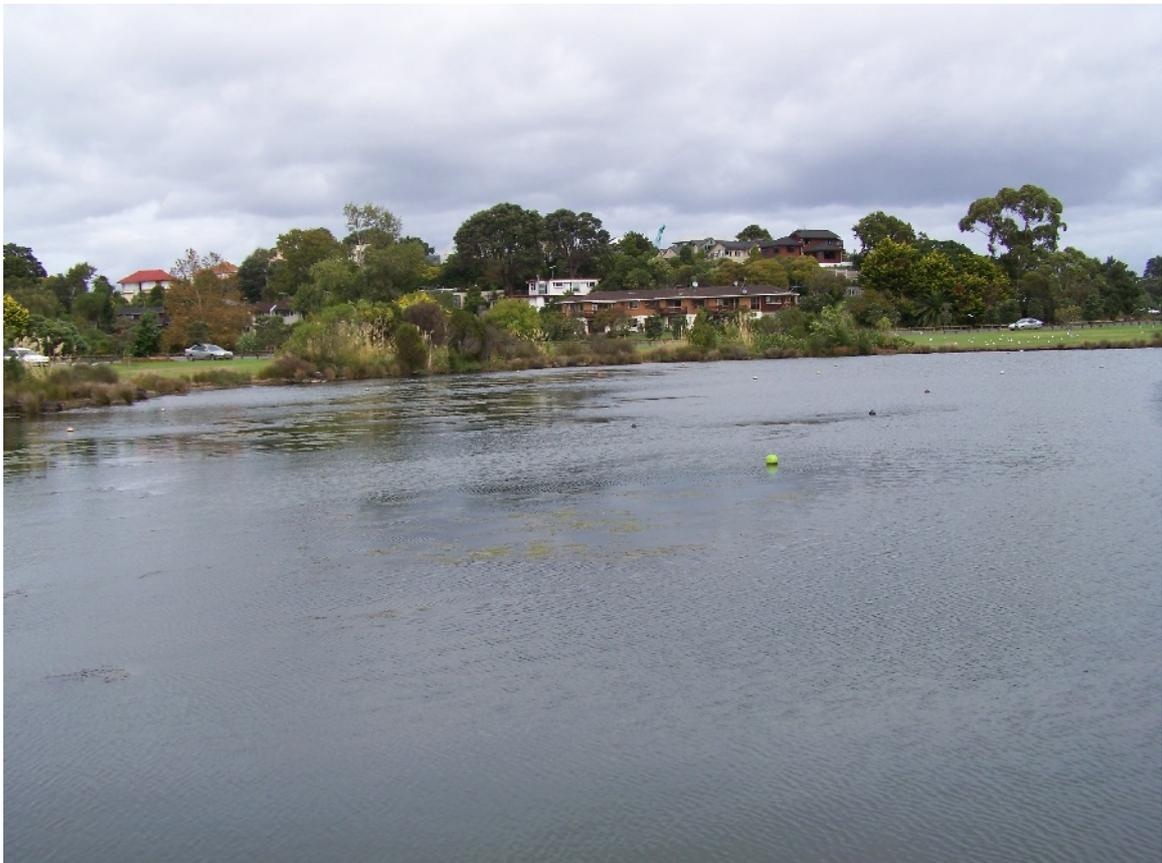
This view from the nothern end shows weed there and in the south east corner with weed clogging about 40 percent of the total pond area.

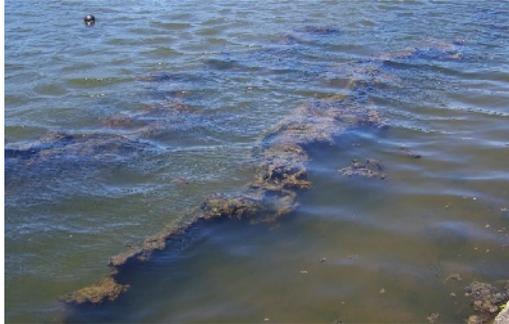
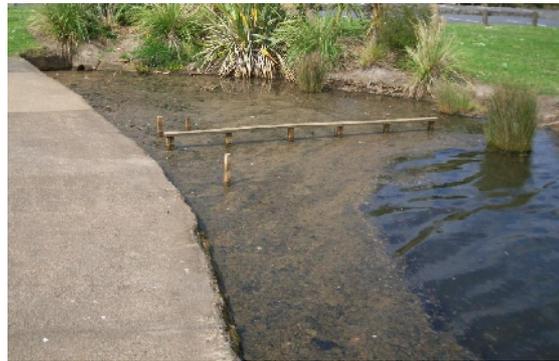
A problem related to the weed is the dead material on the bottom getting a light covering of silt and then decaying and producing gas. When the weather is warm and the sun shines on the shallow edges the decay is accelerated by the heat and the trapped gases cause the bottom to rise to the surface.

This is less of a problem to sailing than the algae as it tends to break up and be blown downwind to accumulate in a corner, but if the wind changes then it is spread over the pond. This then adds to the silting in the shallow edges.

Removing all the silt and decaying matter should reduce this problem. Also the depth of the pond would be increased, especially at the very shallow edges, and this would reduce the heating effect on the bottom. Keeping the weed under control will also reduce the production of decaying matter.

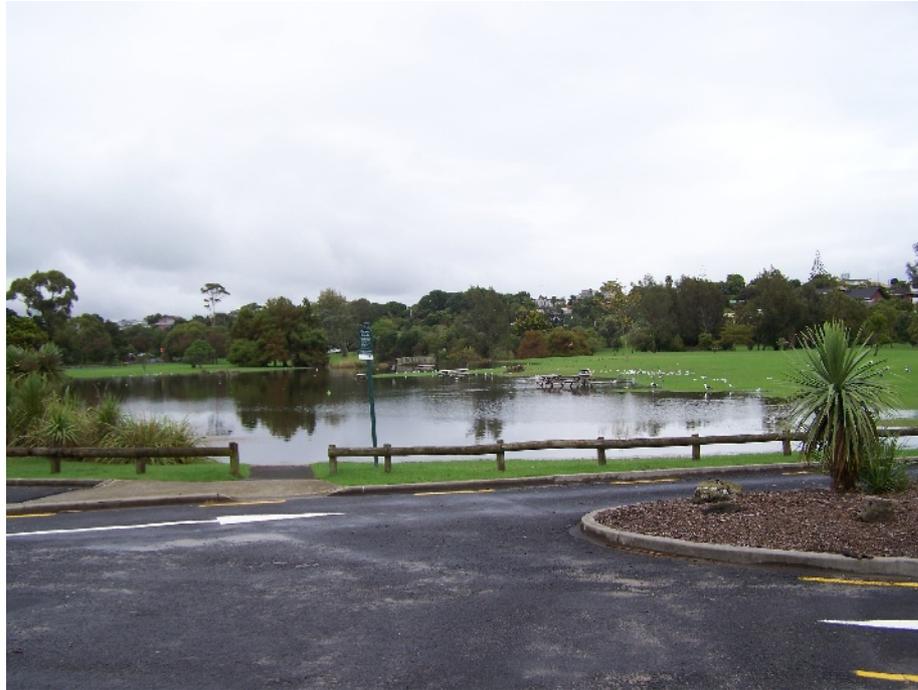
30th March 9:30am after heavy rain overnight.

When there is heavy rain the pond will overflow and, as this will not flow out when the tide is above half way, it may take a day or two to return to normal levels.

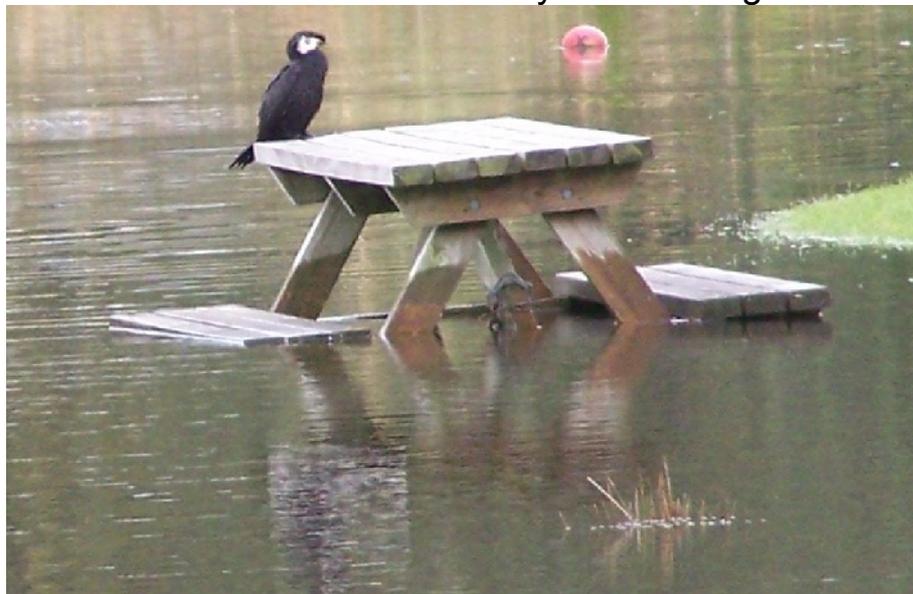
The level had earlier been higher as indicated by the legs of the table. At sunset the level was still the same and as this was high tide (5:31pm) it would be some hours before it started to flow out.

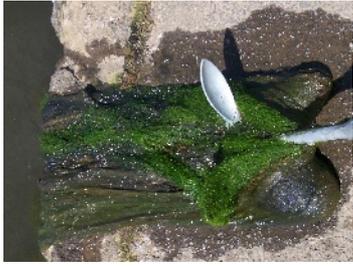
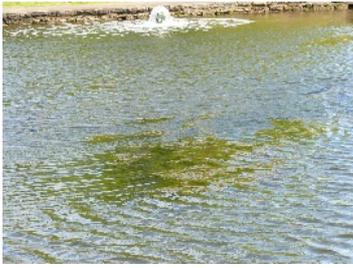
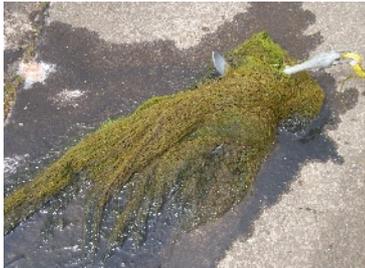
Early October, the weed is green but short.	Late October, some weed is floating.	Late October, weed is long and still green.
