## Sailing 12 December 2010

### Another Rebuild of 01:

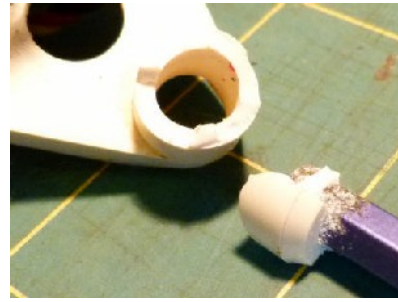
On 01 the servo tray starboard support post socket had disintegrated with some pieces missing.

The servo tray socket was filled with quick setting epoxy and the post put in place. Several bits of ABS were missing so it was necessary to hold the post in the correct alignment until the glue held it. Measurements were made to check that it matched the screw centres as it set.

Because this was not going to be as strong as it was originally, two pieces of fibreglass sheet were glued to the tray sides and to the post to hold it rigidly upright.

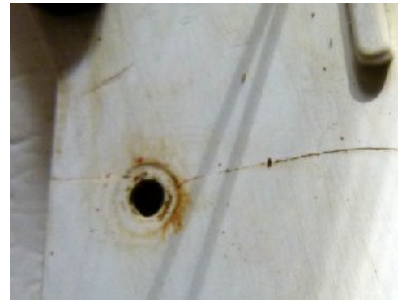
There was also a split across the side deck from the hatch well to the topsides across the support post screw hole.

The latter was fixed by a thin plastic plate epoxied under the side deck.
