Sailing December 06

Club Boat Servo Tray:

New Zealand Radio Yacht Squadron

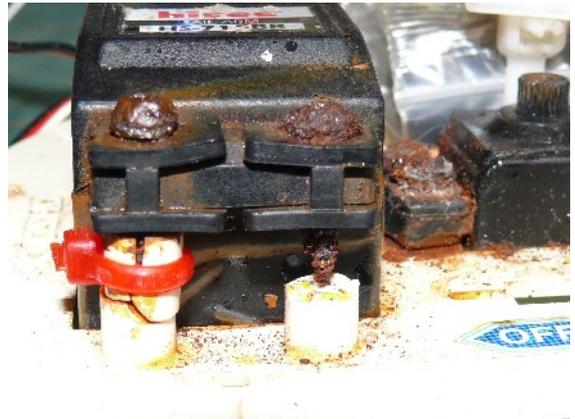
The sail servo on the Club Boat was noticeably loose so I pulled out the tray to see why. The port side support posts had completely broken away. Metal screws tend to apply an outward pressure and when they rust this increases. This had cracked the top of the posts and eventually the sheeting strain broke away the cracked parts. I had earlier applied a cable tie in the hope of limiting the splitting.

Removing the screws holding the servos required pliers as the heads had rusted and the screwdriver slots were no more. Two of the rudder servo screws sheared off.

I cut away the broken stumps and epoxied on a piece of tufnol to replace them. Instead of using screws I drilled right through with a 3mm bit on all the servo screw points, except where a screw body was lodged, and used plated bolts with spring washers underside. A drop of superglue will hold the nuts in place.
