Seawind Rebuild

Seawind 100

In spite of having a new Seawind kit sitting in my basement I have bought a second hand boat and will be rebuilding it. First I will take it apart.

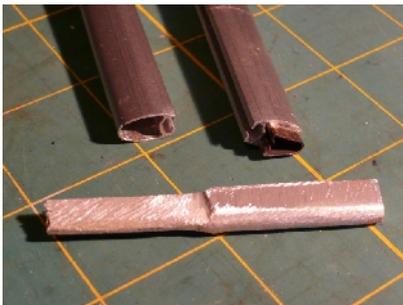
Mast Repair

The result was a typical Seawind mast break. Right at the bottom of the bronze jointer, just where moisture will accumulate, the

dissimilar metals have corroded the aluminum and eaten almost completely through the mast walls.

The corrosion was only around the bottom of the jointer and filing it away left clean metal with

only the loss of a millimetre each end.

An internal splint was made from aluminium as this is easy to work on a disk sander to rough out the

shape and then file to fit. Leaving the surface rough will give a better grip to the epoxy that will be used.

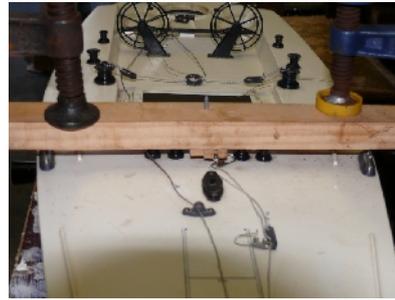
Removing the Keel

The keel had not been glued in but was stuck fast. The stainless keel bolt runs through an aluminium tube and this inevitably corrodes due to dissimilar metals in water. To remove it I needed to press it out.

Penetrating oil was applied to the bulb bolt and soaked down the keel rod. The lead bulb was removed. My Workmate was set to the width of the keel root so that the keel would pass through while the jaws supported the hull and socket.

With the keel nut loosened a beam was placed across it and clamps were positioned each side.

As the clamps were tightened the timber bent, the spacer split, the nail taking the weight was pushed in, but finally the bolt shifted a fraction. More oil, reset the clamps and reapply. Millimetre by millimetre the bolt moved until it was free enough to be driven out with a punch and just the small hammer.

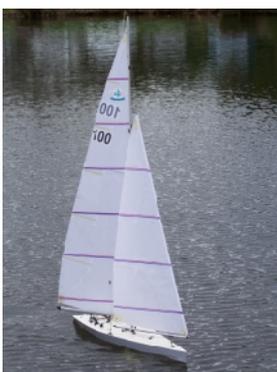
Painting

The hull was sanded, primed and painted grey while the blades were painted white to show when any weed had been caught. The sails were cleaned and battens replaced where they had been lost. Stripes were added to the sails with marker pens to aid boat

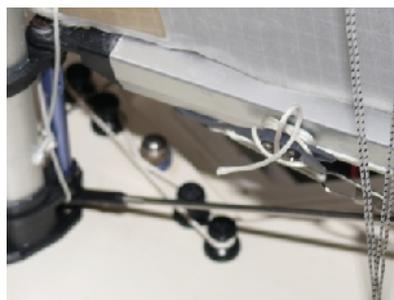
The cleats on the side of the booms to hold the sail clew rope are set towards the rear end of the boom. Thus they can swing out beyond the deck line and can catch in other boat's rigging.

Moving the cleats forward so that they are always within the deck will eliminate this risk. The jib boom cleat must be moved almost to the pivot as the deck is very narrow.

The main boom cleat should be moved so that it is completely within the shrouds otherwise it may catch on these.
