Building a Kyosho Seawind

Beyond the Instruction Sheet

Improving or Rebuilding the Kit Boat

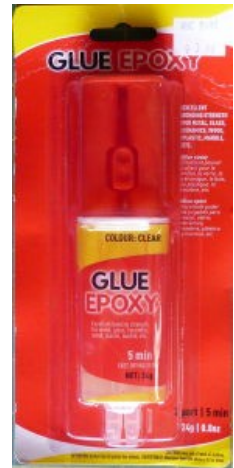
Epoxy is a 2 part glue that provide a strong bond for a variety of different materials. The 2 parts are resin and hardener and these are mixed, usually, in equal proportions. It can be bought in double tubes that help keep the parts equal by extruding both tubes at the same time.

Different formulations give various setting times. The one illustrated is '5 minute' which gives 1 minute working time and then is set is 5 minutes and completely cured in 30.

Surfaces must be prepared by removing all trace of oil, paint or moulding release and, preferably, roughening the surface with fine sandpaper and removing all dust.

Care must be taken in its use.
