Onepoto Lagoon Coordination Committee

November 2007

4. The problems at the pond

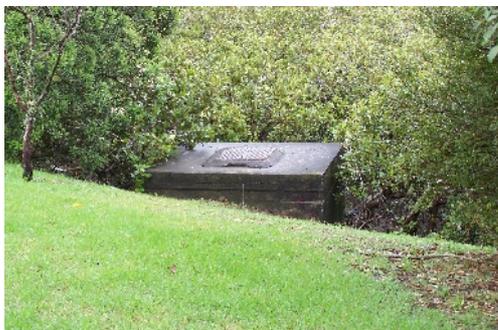
Outflow flaps:

South of the road is the outfall to the estuary and a concrete box holds two iron flaps that allow outflow and control the inflow. A large rectangular cover requires a screwdriver or similar to lever this up to open it.

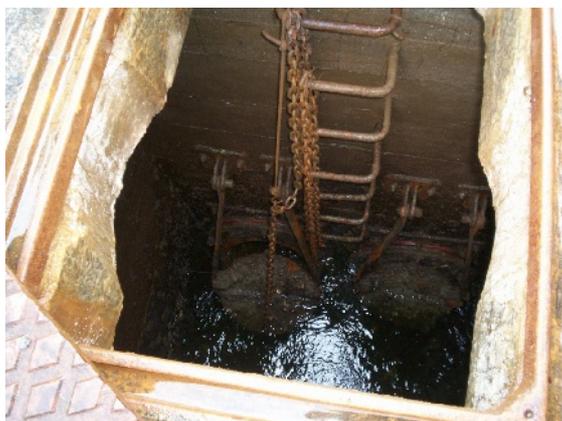
A ladder leads down into the box about 15 feet deep at the base of which are hinged two flap valves covering the outfall pipes. A single chain is looped over the top rung of the ladder and each end is attached to a flap valve.

Normally the flap valves are left free and close as the tide rises. These are pushed open by any outflow at half tide and lower.

When the flaps are closed some leakage will benefit the pond by changing a small amount of the water each tide. Placing the chain between the wall and the flap will allow inflow of an inch or two at high tide which drops back down during low tide.

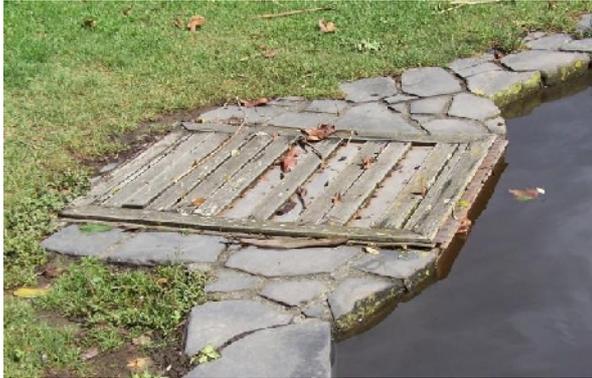
At the south end of the ponds there is the outflow pipe covered by a stainless hinged flap. This is padlocked so the key is required. On the pond side of this is a stainless guard to prevent trash entering the pipe.

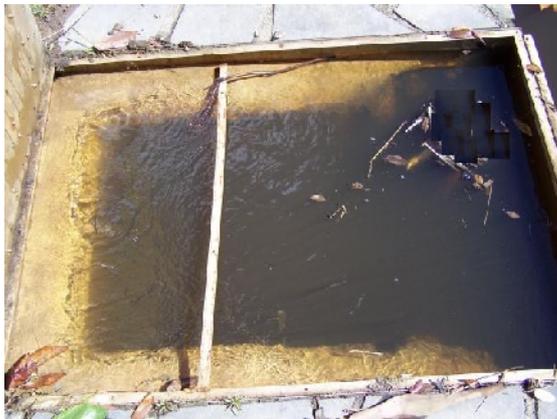
Under the flap is a control dam made up of wooden boards. Normally these are set so the top of the board is at the level required for the pond, any water above this height will spill over the boards and flow out at low tide. This view is with the pond very high.

Update: The angle iron crossbar shown in the photograph has broken away from the frame and sits across the concrete shoulders of the sump. The boards can be left by resting them on the rear shoulder and this bar, possibly tying them in place.

When replaced the boards need to be firmly pushed down and wedged to ensure they don't leak. This is best done when the water is the same level in pond and estuary otherwise the water pressure will prevent seating firmly. It should be checked at low tide and leaks wedged.

The boards cannot be reached without wading when the pond overflows. A vertical rack system is desired which could be operated remotely with a wheel.

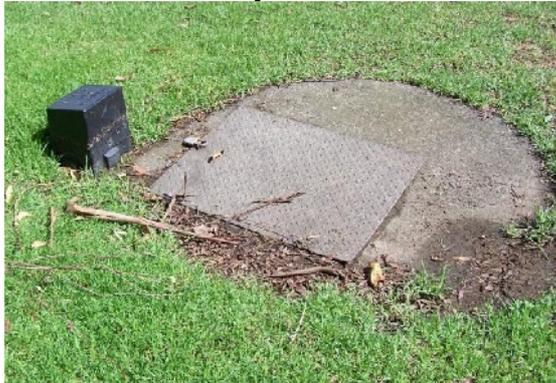
Fountain Pump

An intake a few feet from the outflow feeds an electric pump which emerges as a fountain in the northern lagoon near the bridge. This mixes the waters of the ponds and provides some aeration. The pump is beneath a padlocked lid several feet from the pond

The pump will overheat and burn out if it runs when the pond level is down so it must be switched off if the boards are removed for emptying.

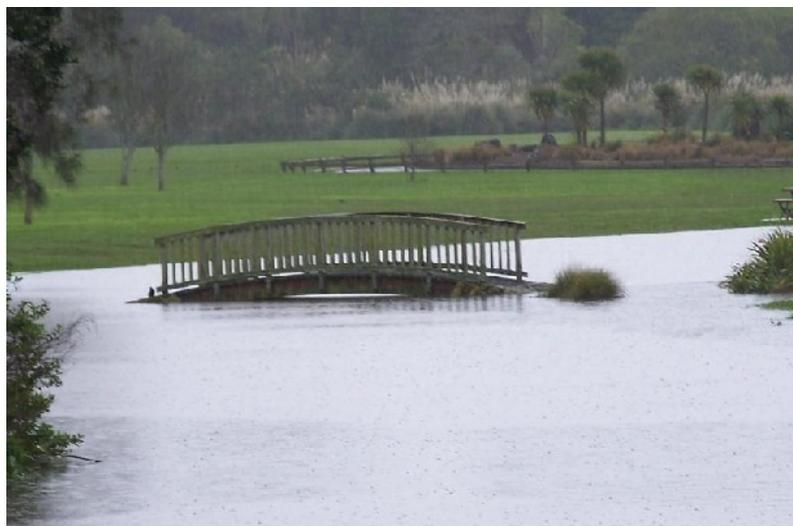
Overflowing

The pond is at about 2.2 metres relative to tide reference. Spring tides range from 0.4 metre to 3.6 metre.

When there is heavy rain the pond will overflow and, as this will not flow out when the tide is above half way, it may take a day or two to return to normal levels.

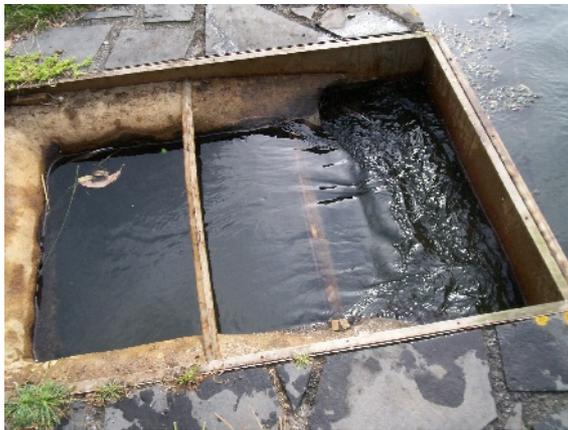
I calculated that two outflows would be completed at just after 10am the next morning and I was there to see that the flow was just a trickle outwards as I opened the flap valves to leave it flushing both ways each tide.

From reading the tide graph (using xtide program) I predicted that at 6pm on wednesday the pond would be slightly overfull with the inflow quite slow. And so it was. I replaced and wedged the boards, closed the flaps, switched on the fountain and fed the ducks.
