## Letters to NZRYS - June 2018

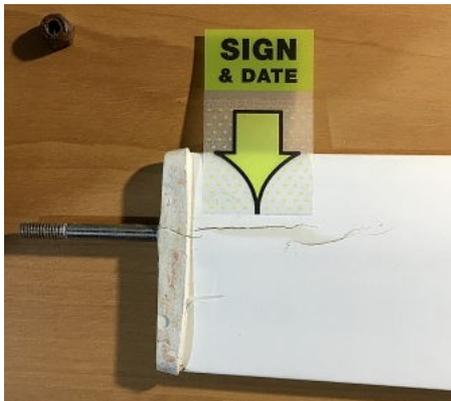
Apologies if I ask a few questions but I'm a newbie to this. I disassembled the fin keel and bulb last night and found there is a crack on both sides of the fin as per attached photo. The locking nut was rusted on the rod but I've got it off. The bulb was loose on the fin keel but I've cleaned the gunk out. I can fill the cracks with Epifill or buy a new fin. Any suggestions of a source for the fin and replacement locking nut. The unit is second hand but seeing I've come this far I may as well do it properly. I'd value your input.

The fin cracking like that is not uncommon. Fortunately, the strength of the fin is derived from the rod which goes from deck to bulb. It may be necessary to scrape the cracks wider to get epoxy deep into them.

The socket in the bulb, because it is cast from lead, is not particularly accurate. I have on one bulb routed it out with a dremel and then filled with body filler, wrapped the fin in gladwrap and inserted it to the correct depth in the filler so that there is a perfect socket when the filler sets. All spares are available at times, but it may be necessary to hunt for them. I am not sure which set of parts has the locknut.

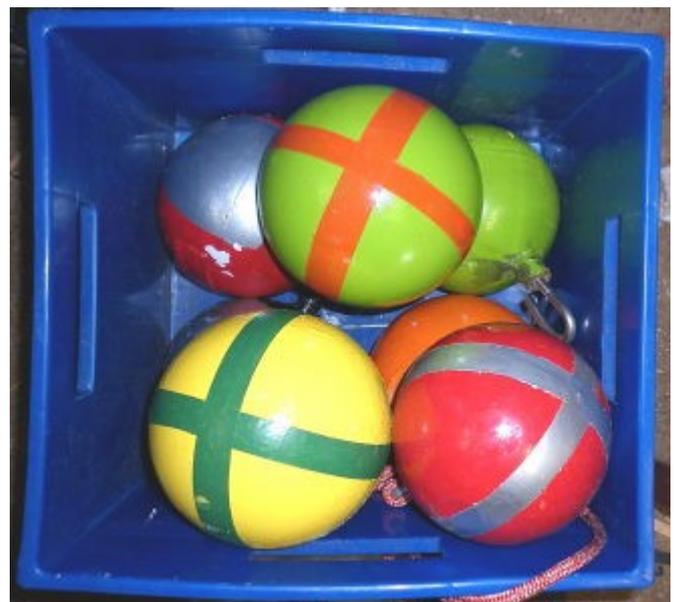
Designing buoy layouts is particularly fraught. I think that extra identification: stripes, quadrants, bands; would be useful. I still have several buoys here, some of which have added id items (photo attached).
